Feather Receives Significant Upgrades

Artisan Boatworks specializes in the restoration, storage, and maintenance of Concordia yawls and other classics from the same era, serving present-day owners who continue to sail and care for these remarkable boats. The yard is owned and operated by yours truly, Alec Brainerd. My team and I were honored this past winter to undertake a comprehensive aft-end restoration for FEATHER, a 1955 Concordia 41 yawl (#29). This project involved numerous separate tasks, upgrades of the sort these boats typically require to remain safe and relevant as they age. All the work was accomplished at our shop facility in Rockport, Maine.

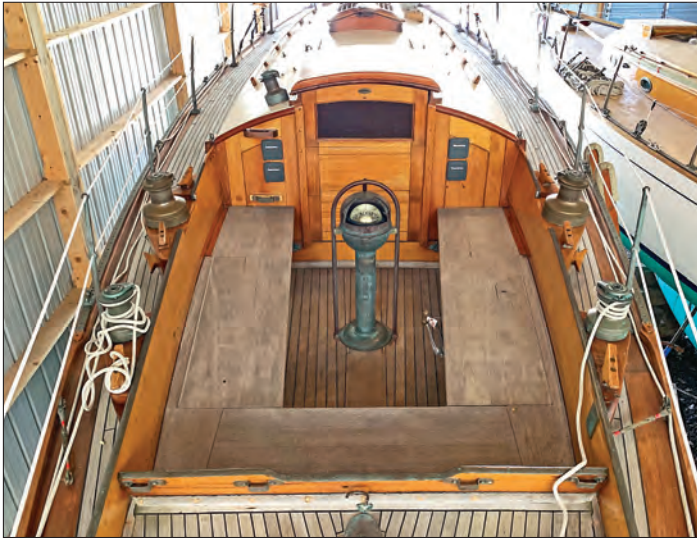
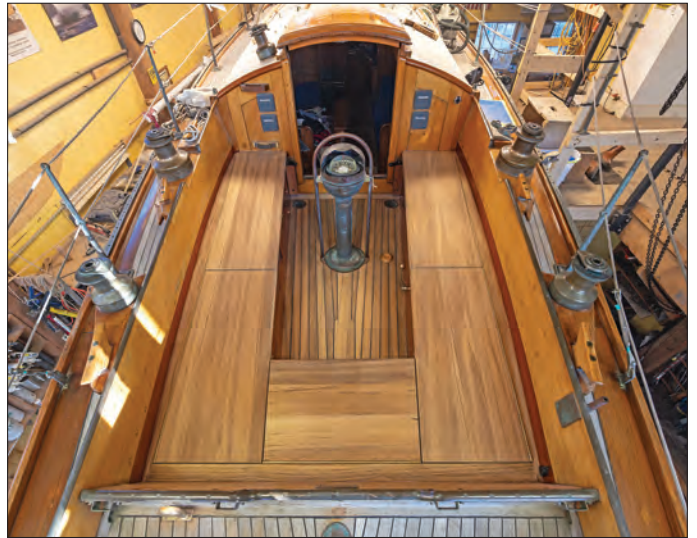
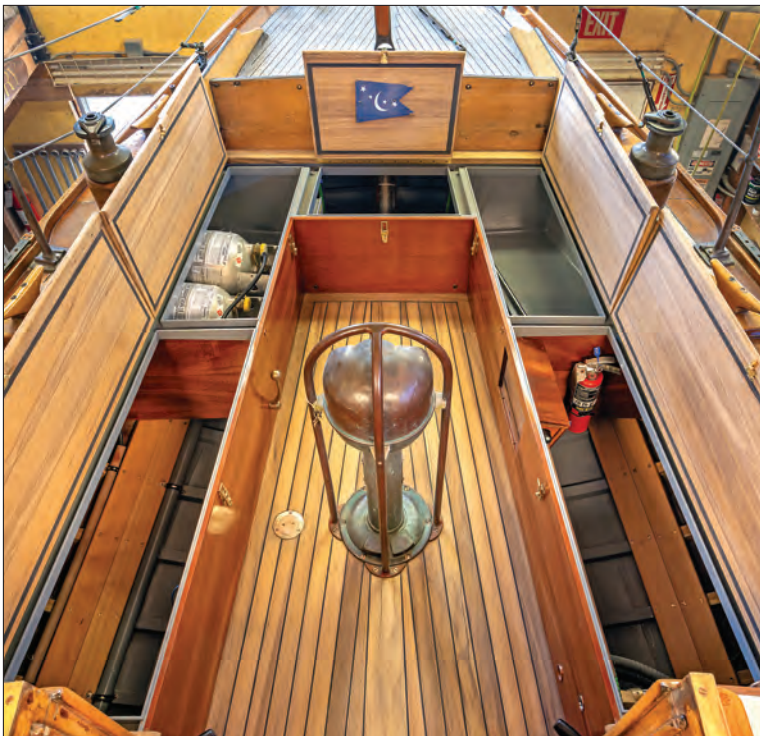
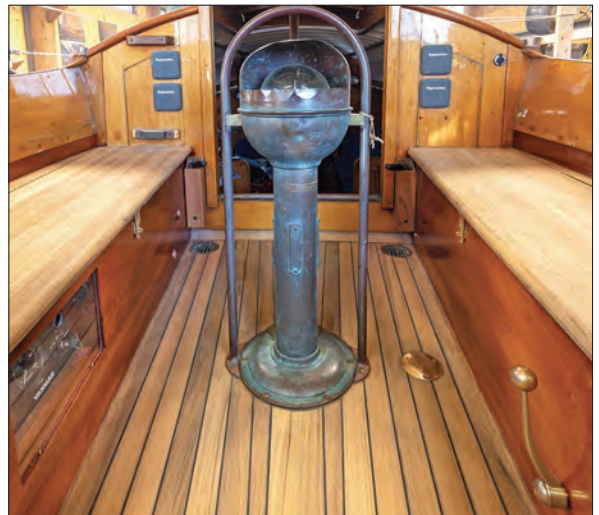
The first photograph here (above left) illustrates the cockpit area prior to the commencement of this winter project. The other three photos were taken in April 2026, after the job had been completed. Rob Root served as the lead carpenter for all the modifications we made to FEATHER.

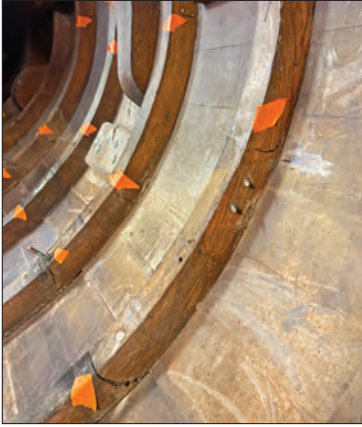
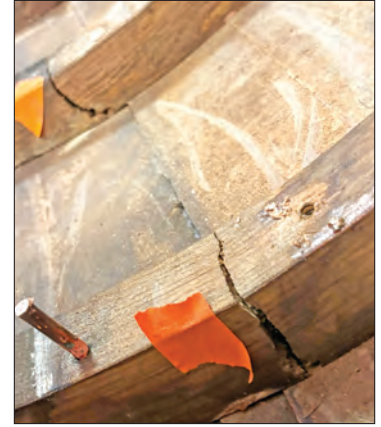
Several years ago, a surveyor found some minor rot in the aft corners of FEATHER's cockpit, and he also identified several cracked frames aft, which were visible through the access openings at the forward end of the cockpit well. All seemed relatively stable at the time, so addressing these concerns was delayed until there was a convenient opening in our carpentry schedule. When we at last began to disassemble the boat's cockpit, however, a far more extensive issue was revealed: all 30 frames from the cockpit bulkhead to the transom were broken. Many had fractured in two or three places, and it's probable that these members had been compromised for a number of years.

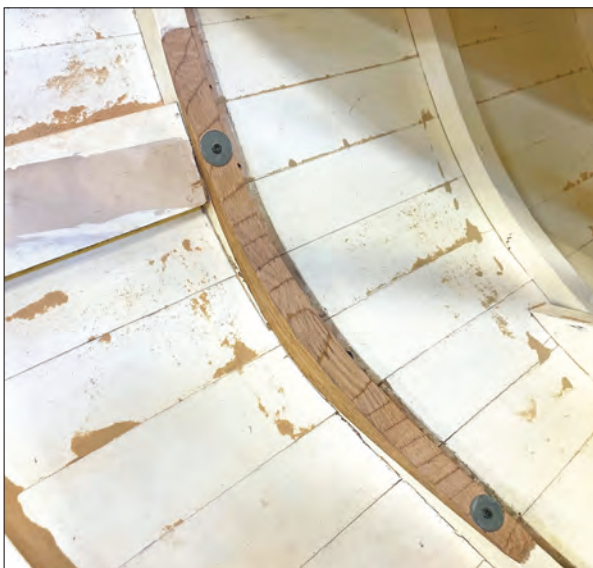
In some cases, cleanly broken steam-bent frames can be healed: we trim back the wood on either side of the break to a 10:1 slope and laminate in a new segment which, once trimmed flush and smoothed, is virtually indistinguishable from the original (see photo at left). This sort of repair can readily be carried out in the center section of a boat like FEATHER, where the frames are long and there is good access for performing the work. Toward the ends, however, where the frames are shorter, and especially aft where the bends are tight, replacing the frames entirely is the only reasonable path. Presented with the choice between sistering FEATHER's broken frames, replacing them with new steam-bent oak frames, or installing new laminated oak frames, the boat's owner determined that there was only one way to proceed: perform the repair in the best manner possible, namely the third option.

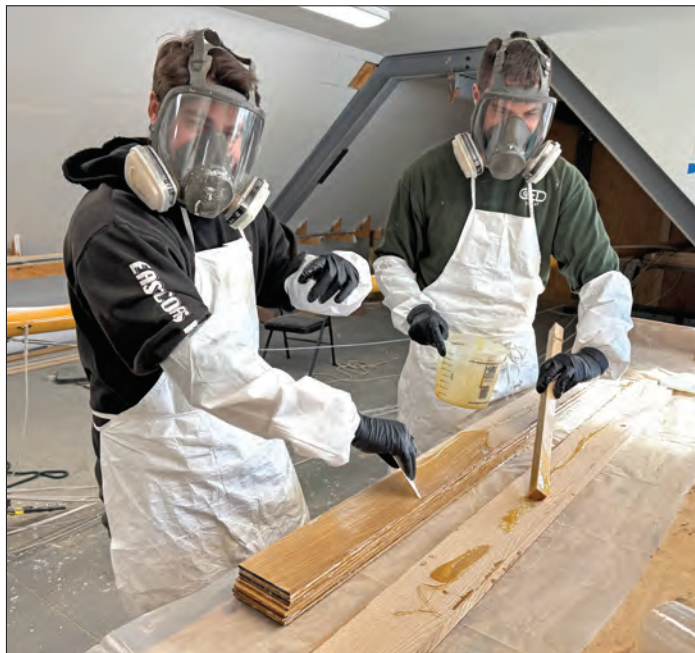
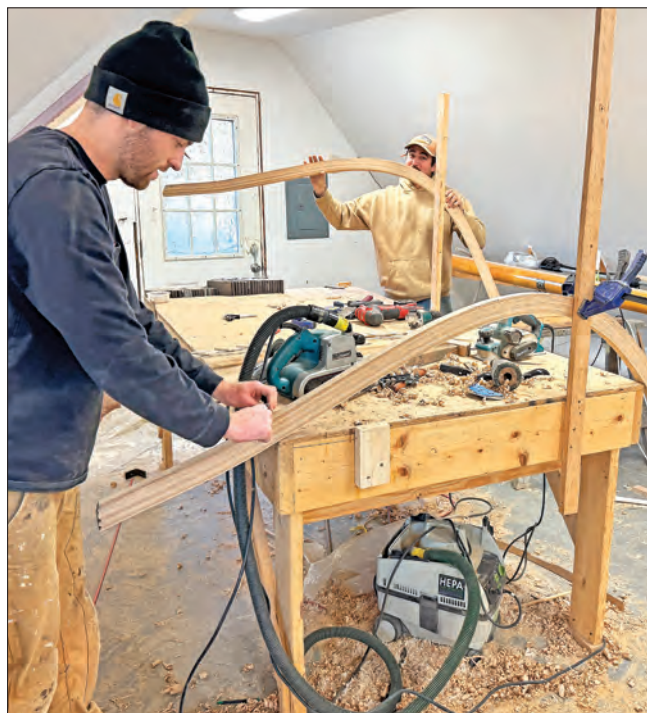
We therefore proceeded to replace FEATHER's 15 pairs of broken frames with new laminated members. Rob Root and Kai O'Connor began the process by preparing blanks made up from 3/16" white oak flitches, which were bonded with West System G/flex epoxy.

Following precise patterning, the frame blanks were glued up at double thickness. In a technique relatively common in our trade, the blanks were then ripped in half lengthwise in order to create matching pairs of symmetrical frames, one for each side of the boat.

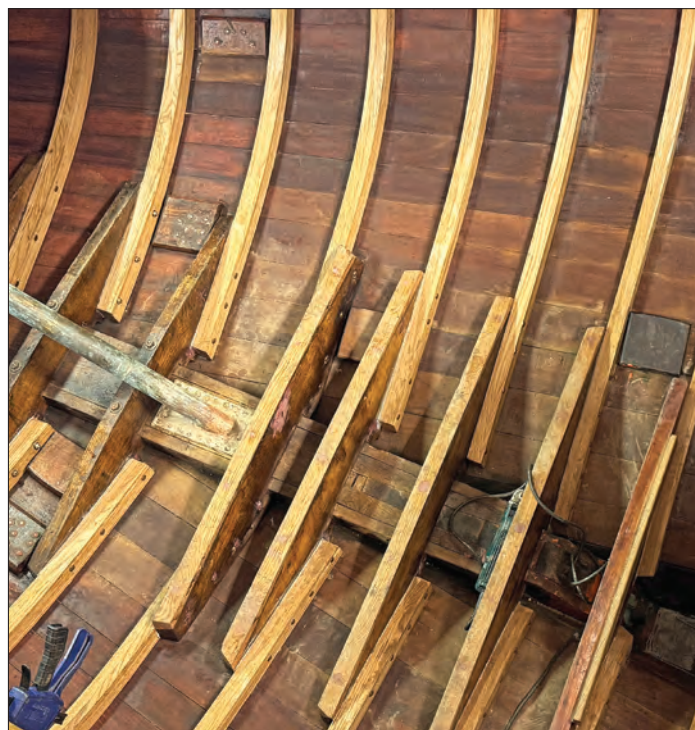
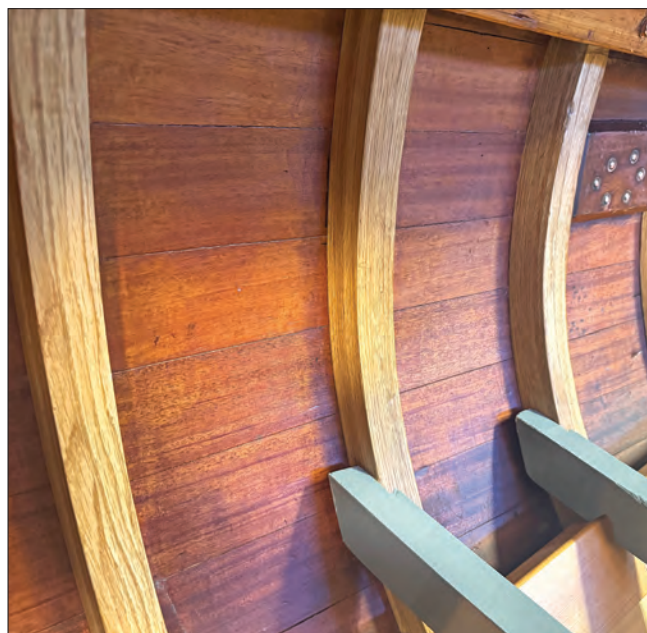
All frames were beveled inside and out to match the planking, and they were subsequently installed with new bronze screws and bolts that tied them into the sheer clamps and floor timbers.

During this entire process, we were quite careful to preserve the longitudinal fairness of the hull, and we were also able to eliminate a knuckle that had begun to form at the plank seam running along one line of breaks. Once the frames were replaced, the inside of the planking was refinished, using matte varnish in the upper portions and gray Interlux Bilgecoat below.

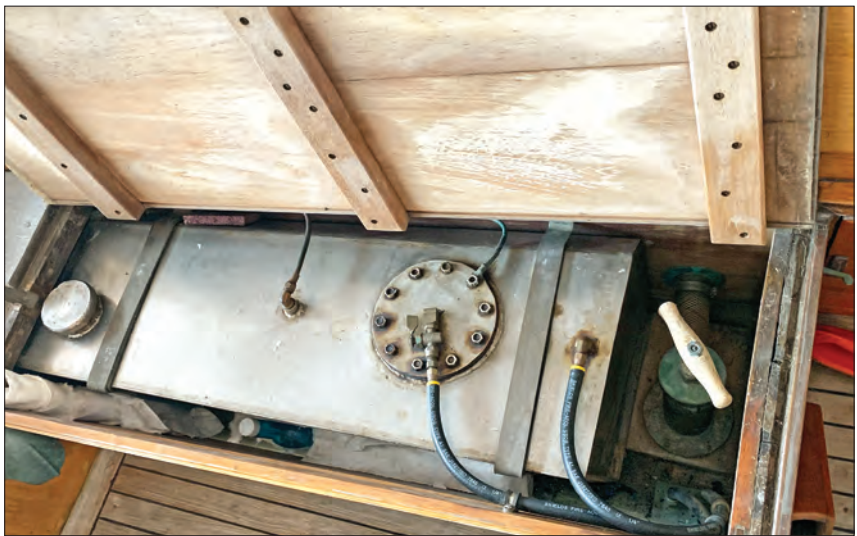
The standard Concordia fuel tank is located under the port cockpit seat, and holds around 20 gallons. Achieving additional storage space was a priority for FEATHER's owner, as was increasing range under power without the need to carry diesel fuel on deck in yellow jerry cans.

With the cockpit sole beams clamped temporarily in place, we patterned a new fuel tank to fit within the space between the tops of the floor timbers and the bottoms of the beams. The new custom tank, made from aluminum and seen here following its installation, holds a total of 45 gallons.

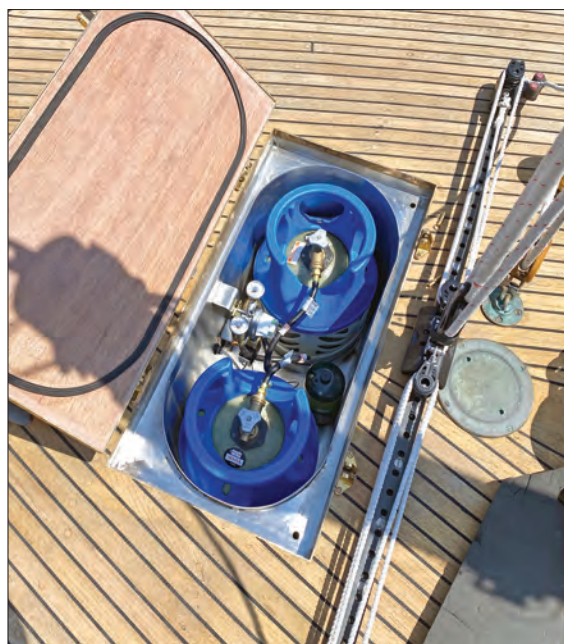
The photo to the right, which was taken aboard the Aage Nielsen sloop DELPHINUS, shows a successful propane arrangement of a sort often seen, namely a sealed and vented locker recessed into the aft portion of the deck; DELPHINUS was built by Paul Luke in 1965, and the boat has been in Artisan's care since 2020. Replicating this sort of arrangement on a Concordia would be challenging, and would require giving up much of the lazarette.

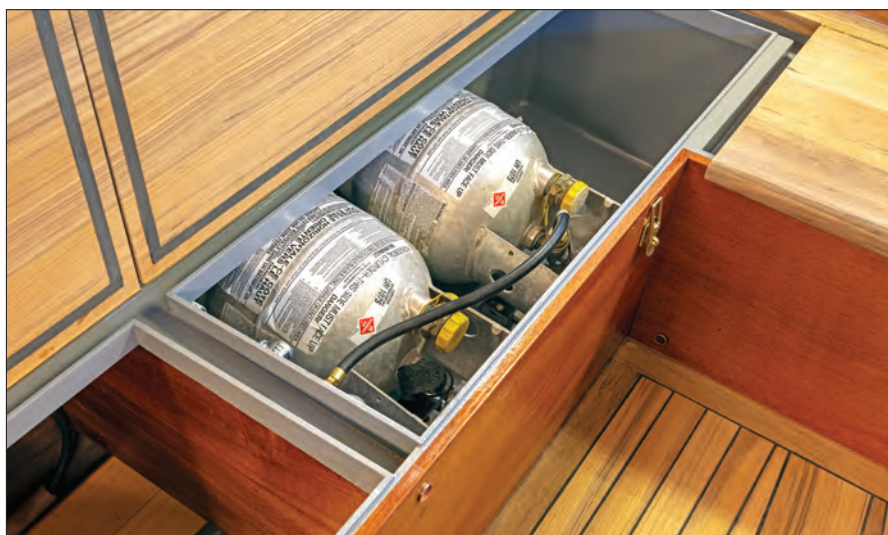
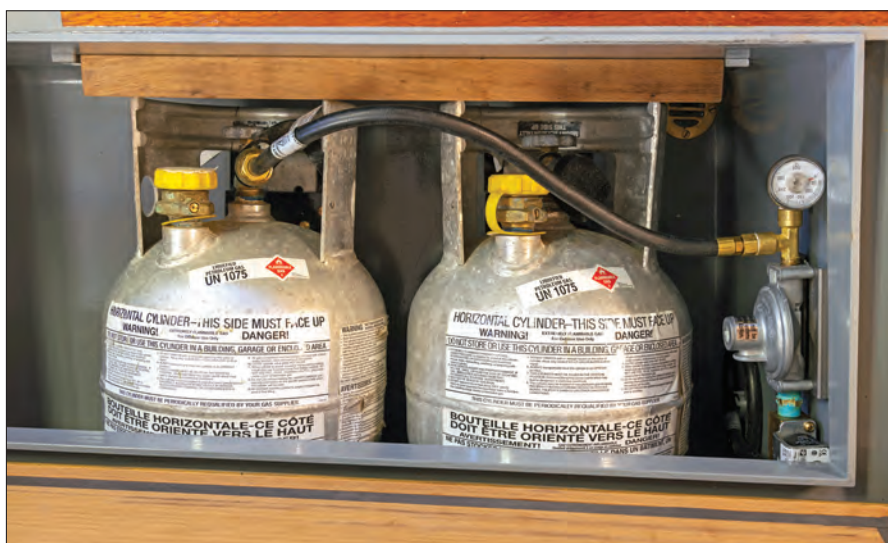
Over the years, I have seen various “off-the-shelf” propane enclosures that can be located below decks, at least in theory. These units may technically meet the letter of the ABYC recommendations, but in my opinion they do not satisfy the intent, nor are they particularly safe. Any fumes that leak from an inadequately sealed lid or escape when the lid is opened will flow straight into the bilge. For FEATHER, we opted to build symmetrical watertight storage lockers in the aft quarters of the port and starboard cockpit seats. These lockers were made using 1/2" marine mahogany plywood sheathed with 10-ounce fiberglass cloth, and they have filleted corners and gasketed lids. The starboard side locker, which is dedicated to propane, provides secure mounting for the two tanks and is properly equipped with a drain leading directly overboard.

In my judgment, this cockpit seat locker location for propane storage is the best setup for a Concordia. In theory, given sufficient time and flow volume, fumes escaping the gasketed locker lid could flow into the cockpit footwell rather than overboard. Though water in the cockpit drains would block the flow of propane gas, those fumes could theoretically fill the footwell and then find their way down the companionway opening. In reality, however, I do believe that there is sufficient airflow in and around the cockpit to dissipate any fumes. All boats with propane systems should also be equipped at minimum with one propane sniffer in the lowest part of the cabin and another near the stove, connected to an alarm and an automatic shut-off valve at the tank.

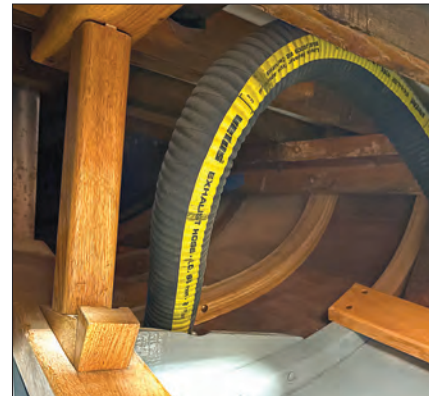
Many Concordia yawls were built with a tee in the engine exhaust, splitting just aft of the engine and exiting at the waterline on both sides of the boat, outboard of the cockpit. When motorsailing, fumes are in theory directed to the leeward side of the boat by the venturi effect. Yet when powering on light-air days, exhaust can still manage to find its way to the cockpit area, in unpleasant fashion.

Removal of FEATHER's old cockpit soon revealed that the 1½" exhaust through-hulls on either side at the waterline were badly deteriorated and also not securely connected—and they had of course been nearly impossible to access for inspection and maintenance. In a new solution for the exhaust, we ran a single 2½" hose from the muffler to an exit point under the counter, echoing the setup seen on most modern boats. The combined cross-sectional area of two 1½" hoses is 3.5 square inches, whereas the comparable area of a single 2½" hose is 4.9 square inches. The original exhaust was likely of sufficient capacity for FEATHER's original Gray Marine gasoline engine, but it was definitely undersized for the 55-hp Yanmar diesel the boat carries today. The new exhaust—with a single run of larger hose and fewer fittings and bends—should significantly improve flow and reduce back pressure, and will also help to keep fumes away from the cockpit.

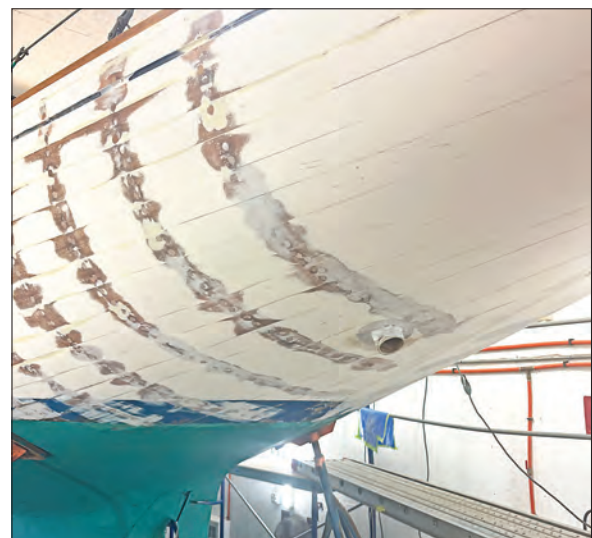
The photo just to the right shows the revised position of the exhaust outlet, now in the counter. The boat was in the paint bay at this point, with extra attention being necessary this year since the topsides were necessarily disturbed during reframing.

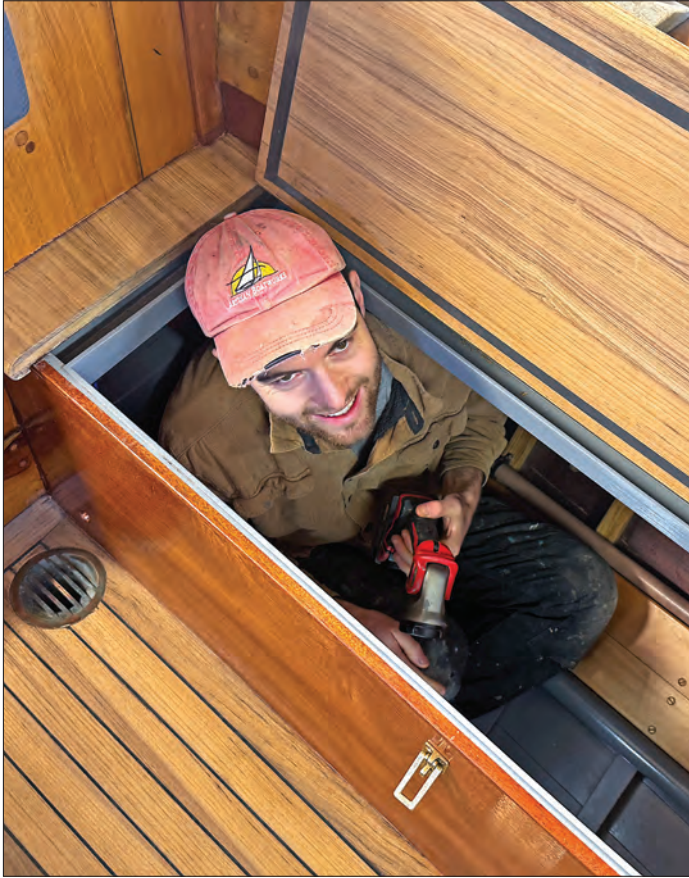
In Concordia yawls as built, accessing the area beneath the cockpit is difficult, and thus it is quite challenging to adjust the stuffing box, tend to the transmission linkage, or (heaven forbid) close a through-hull in an emergency. We determined that a primary goal of our redesigned cockpit would be to solve the issue of access to this particular area. One way of accomplishing that is to install a flush hatch in the cockpit sole, just aft of the bridge deck. Yet potential water ingress then becomes a consideration. And in FEATHER's case, the compass binnacle was in the way.

A preferable solution, in my opinion, is the manner in which things are arranged on NORA: rather than opening to an area extending down to the cockpit floor only, the cockpit seats open directly to the inside of the hull. Gutters and gaskets render the lids watertight, and there is ample space for an average-sized person to climb right in, and out the other side if desired. The lids can be tied open for light and ventilation during maintenance operations, and interior components can be safely accessed even while under way. The other advantage to deep lockers is that they provide more than adequate storage for multiple fenders and dock lines, a boarding ladder, and other gear. One loss with this arrangement is the T-shaped Concordia cockpit layout, which can be created by removing the forward sections of the port and starboard seats. We checked with quite a few Concordia owners, and most reported that they never take out those removeable seat panels.

Abeking & Rasmussen used solid mahogany boards for the cockpit coamings, lengths of solid teak caulked with cotton for the footwell, and solid teak for the seat tops. Though FEATHER's seat tops had held up for 70 years, it was clearly time for replacement. Rather than using solid hardwood once again, we opted to employ 1/2" marine mahogany plywood, to which we applied a 1/4" veneer of teak on both sides. This approach precludes any warping or checking, allows us to select for the best possible grain pattern and orientation, and provides ample thickness of solid wood for another 70+ years of wear. When veneering plywood, it is imperative that both faces of the substrate are veneered. If even a thin layer is bonded to one side only of a plywood substrate, the piece will warp like a potato chip.

Gaskets on the inside of each cockpit seat meet the tops of the inner drain gutters, and latches keep the seats fastened down tightly. Now that the seats open into the hull, these measures ensure that no water can make its way into the boat via the seat openings. This photo also shows the storage location for the handle that operates FEATHER's new Edson bilge pump.

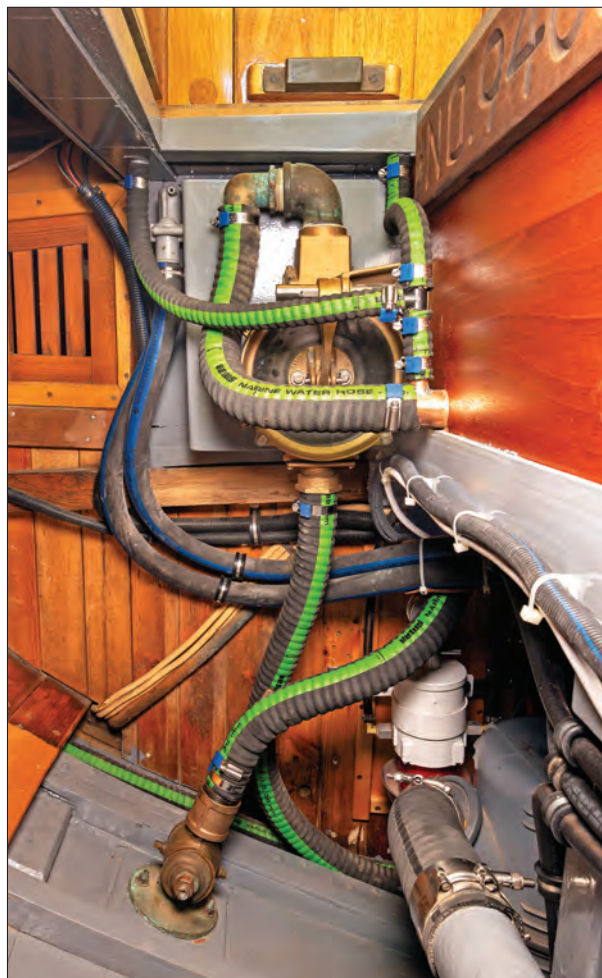
As is evident in the lower right of the photo below, FEATHER formerly had a very complicated assortment of drain hoses, all coming together in a manifold leading to the cockpit drains. Every time two hoses tee together, it means more fittings and clamps that can fail, as well as increased turbulence leading to reduced flow.

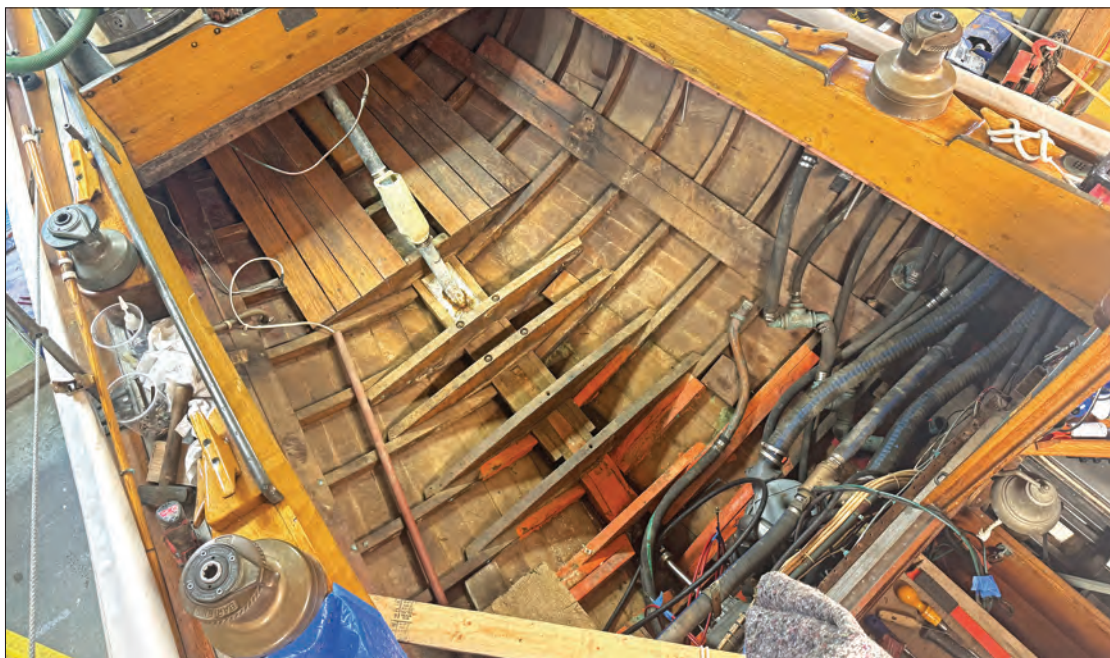
At the previous locations of the port and starboard exhaust through-hulls, FEATHER now has brand new 1" Groco through-hulls with seacocks, one serving the primary bilge pump and the other the secondary pump. Next to these are waterline through-hulls for the scupper/deck drains. To prevent any back-siphoning, the hoses from the bilge pumps travel up through vented loops just under the deck before dropping back down to the through-hulls. Now that the pumps and drains have dedicated through-hulls, each of the two main cockpit drains follows an unencumbered straight run down to its own through-hull. The great profusion of hoses, fittings, barbs, tees, and hose clamps formerly present has been much reduced, which is all to the good.

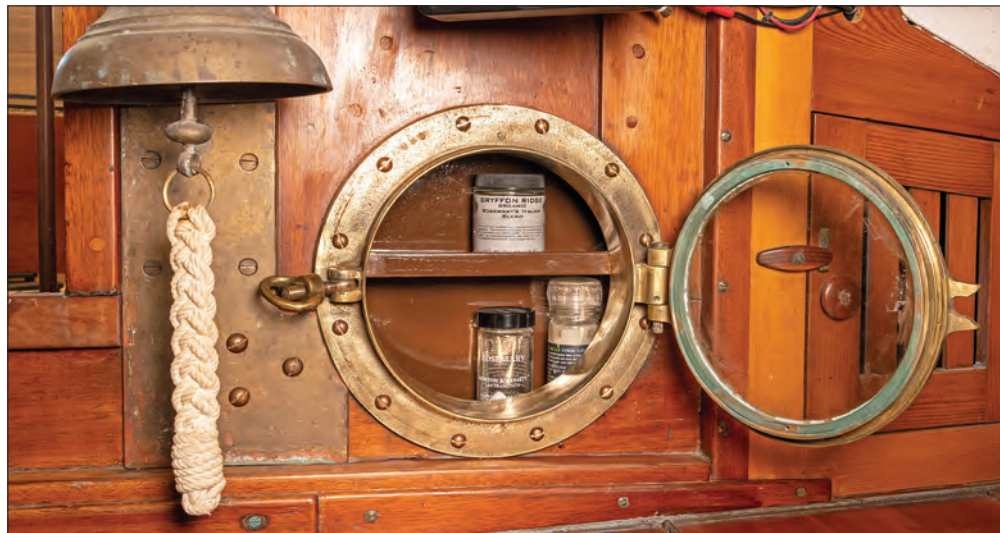
When we eliminated the lift-out seat inserts at the forward ends of the cockpit, this raised a question: what to do about the original bronze footwell portlight? The opening is such a distinctive Concordia element that it seemed wrong to eliminate it altogether. Yet it now opened into a dark cockpit locker.

It's always best when such a problem (or worse, an outright mistake) can be resolved by creating a net-positive detail that looks purposeful. Thankfully, my crew arrived at one of those brilliant solutions while determining a good place for mounting the new manual bilge pump. In order to position the Edson pump with the discharge low and near a cockpit drain—and have the removable handle pass through a slot in the footwell—the best position for our desired orientation was the forward end of the port cockpit locker, right where the portlight was located. It was also necessary to space the pump about 4" off the bulkhead, in order to afford adequate swing room for the handle.

There we were in the cabin one day, discussing the likely elimination of the portlight and wondering just how to patch the resulting 8" hole in a way that would match the surrounding varnished joinery. All of a sudden: voilà! Rob (or maybe it was Kai) came up with a brilliant idea: fashion a round wooden component of suitable thickness for mounting the pump, and finish it out on the other side as a galley storage nook—the door to which would be the bronze portlight. The owner approved of this clever suggestion, and the result was a success all around.

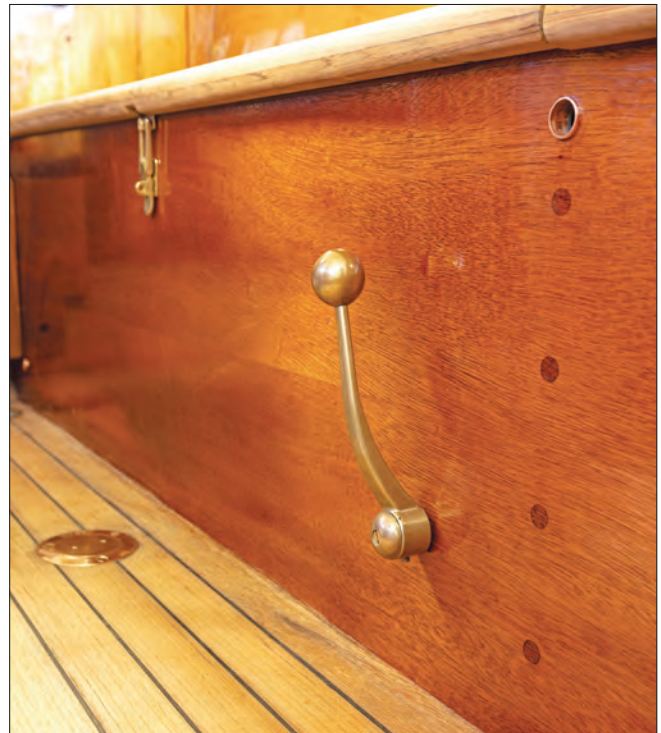
One last piece of the puzzle involved the engine controls. Purist Concordia owners may wish to stop reading here, for there is doubtless considerable pride associated with the acquired skill of managing the tiller with your legs while operating the throttle with your right hand and working the shifter with your right leg – all while docking the boat or picking up a mooring. After all, sailing is a sport. Non-purists, however, may rejoice to learn that Kobelt makes a beautiful all-bronze assembly that handles shifting and throttle control with a single lever. We positioned the control lever (seen below) on the right side of FEATHER's footwell, where it is easily reached. Also visible in the background is one of several bronze latches we installed, which keep the cockpit seats tightly sealed when closed.
