Glued-Edge Carvel Planking *Bucking convention at Artisan Boatworks*

by Matthew P. Murphy

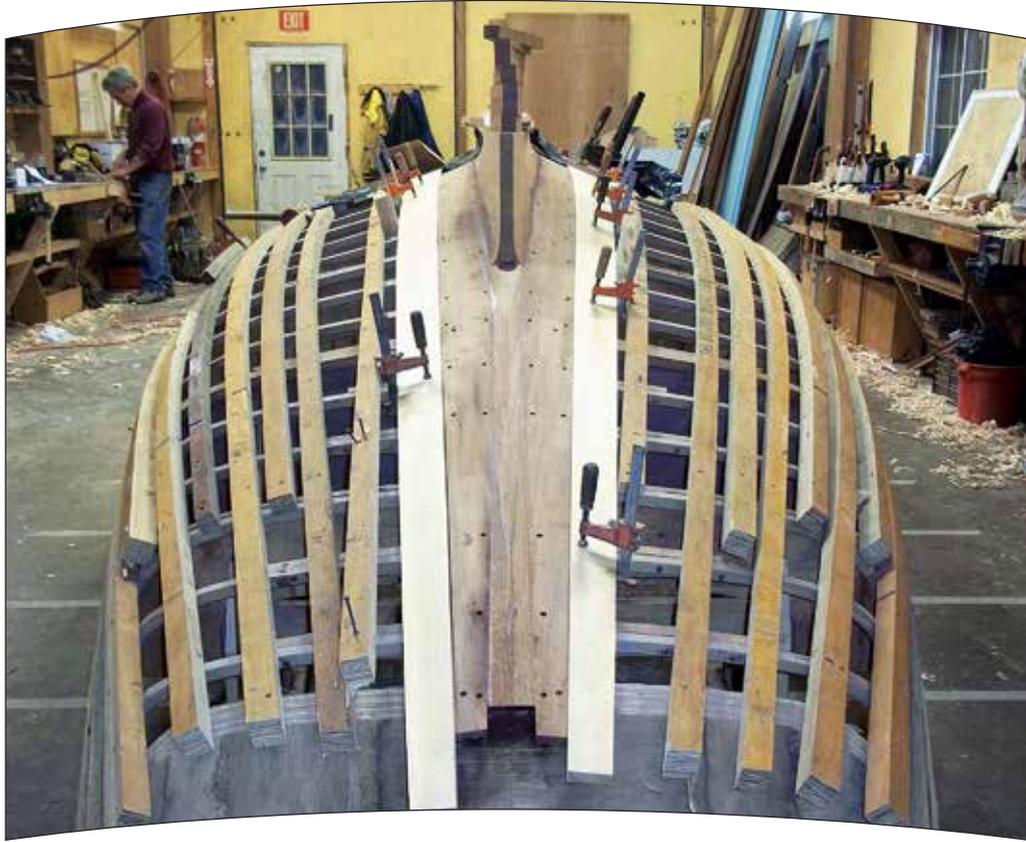
Above—Artisan Boatworks of Rockport, Maine, has built a fleet of fine daysailers whose cedar planks are glued together rather than caulked and payed. The Buzzards Bay 15 pictured above has its mahogany garboards glued and screwed in place, and the first broadstrakes, of northern white cedar, are fitted and about to be fastened.

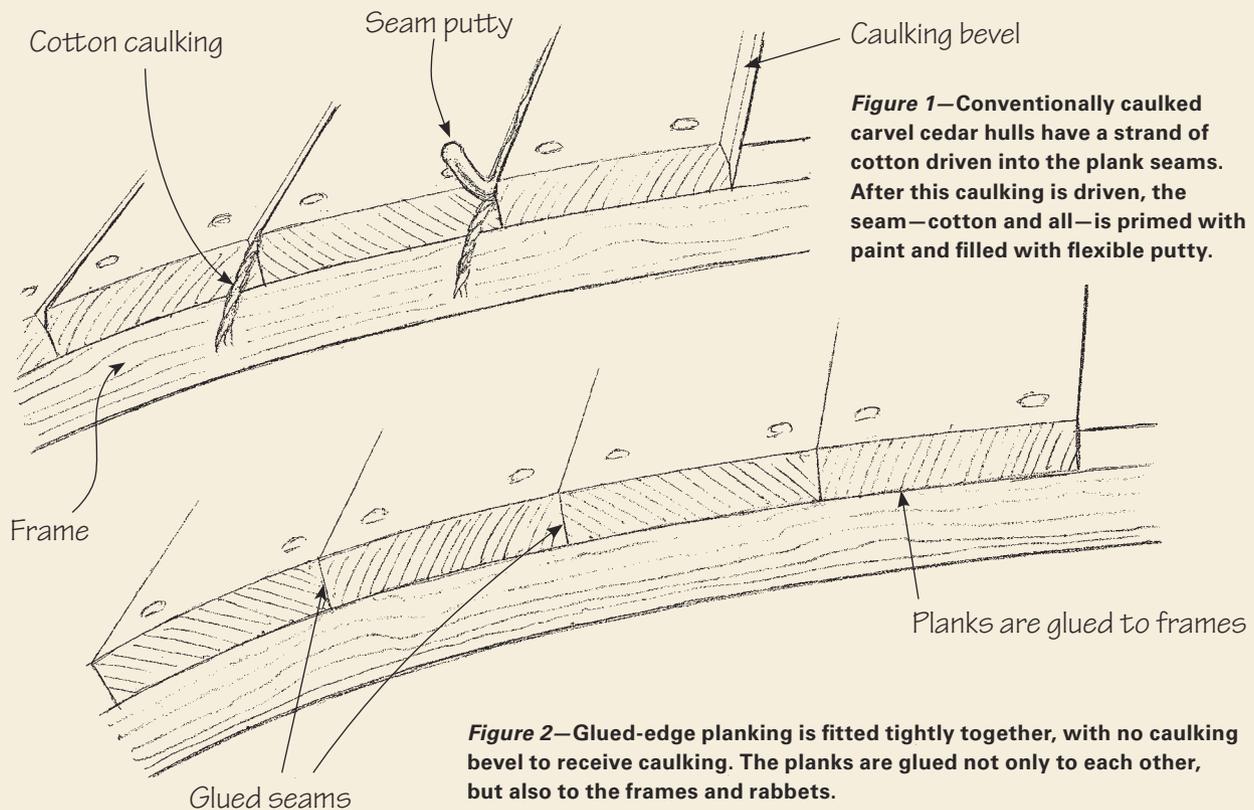
Figure 1—Conventionally caulked carvel cedar hulls have a strand of cotton driven into the plank seams. After this caulking is driven, the seam—cotton and all—is primed with paint and filled with flexible putty.

Figure 2—Glued-edge planking is fitted tightly together, with no caulking bevel to receive caulking. The planks are glued not only to each other, but also to the frames and rabbets.

The daysailers built by Artisan Boatworks of Rockport, Maine, are planked in a seemingly common manner, with a single layer of fore-and-aft cedar screwed to closely spaced oak frames and floor timbers. But the conventional aspects end there, for instead of being caulked in the usual way, with a strand of cotton driven into a beveled plank seam and covered by putty (Figure 1), the planks of these boats are simply glued together, edge-to-edge (Figure 2).

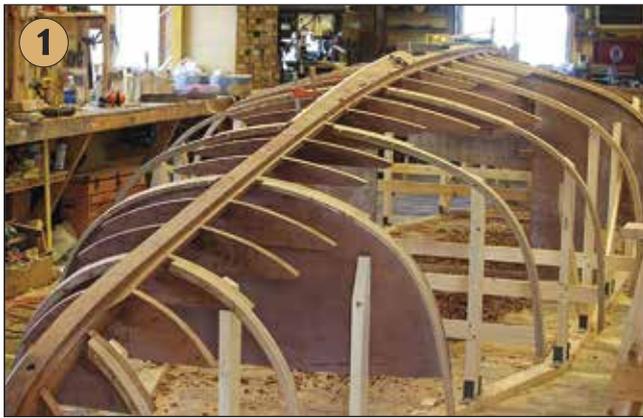
Photograph 1—The setup: Each third frame is laminated to its precise shape, and permanent bulkheads are in place. Boatbuilders will note the absence of temporary molds. **Photograph 2**—The rabbet has been cut in the laminated mahogany keel, and intermittent steam-bent frames are now in place. **Photograph 3**—The garboard has been spiled and cut to shape, and glued and screwed into place.

There's very little wasted wood in Artisan Boat Works' building jigs. Instead of placing a mold at each station, the crew laminate every third or fourth frame from oak on the loft floor, and place these in their proper positions on the setup. The plywood "molds" we see in the skeletal setup in **photograph 1** (following page) are permanent bulkheads, and so will remain a part of the boat's fabric. Once the laminated control frames and bulkheads are set up, the remaining frames are steam bent inside of longitudinal temporary ribbands.

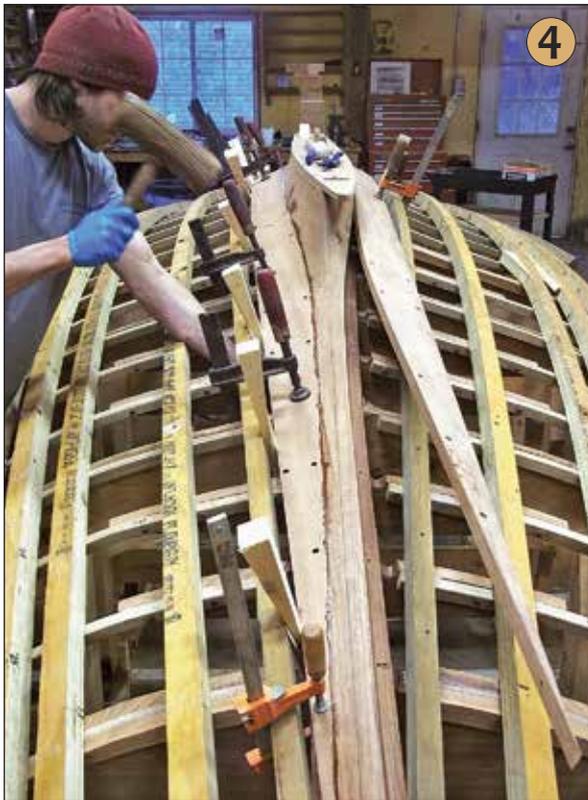
Photograph 4—Wedges are driven between a hefty ribband and the glued-in-place garboard, driving the plank tight into the keel rabbet. **Photograph 5**—The cedar broadstrake is glued and screwed in place. **Photograph 6**—Excess glue is cleaned from the interior as well as from the limber holes in the floor timbers.

(**photograph 3**), epoxy glue is spread along the garboard seam as in **photograph 4** (page 62), and on each frame where the plank lands on it; then it is screwed in place (**photograph 5**). The squeezed-out glue is then cleaned from the interior (**photograph 6**). The next plank is applied in a similar manner: spiled, glued to the frames and its neighboring planks, and screw-fastened. When the planking job is complete, the planks have all been glued to each other, to the backbone structure, to the frames, and to the laminated plywood transom frame. It is, essentially, a monocoque hull, like one that's been cold-molded, but the effort spent is considerably less.

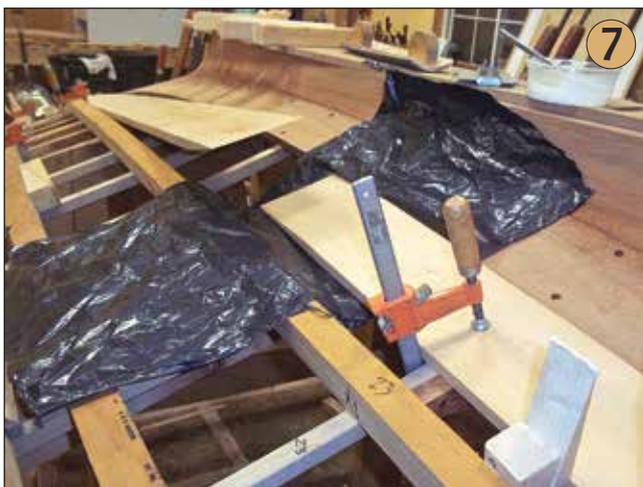
Photograph 7—The broadstrake is made from two shorter planks scarfed together in place on the boat. **Photograph 8**—The completed plank scarf. When faired, sanded, and painted, the joint will be invisible and secure.

As is common in many shops today, Artisan Boatworks also has eliminated butt blocks from its hull planking, choosing instead to scarf-join their planks together end-to-end (see WB No. 215) right in place on the boat (**photographs 7 and 8**). Not only is a glued scarf stronger than a butt block, but it also eliminates a potential source of leaks—and a potential flaw in the eventual finish.

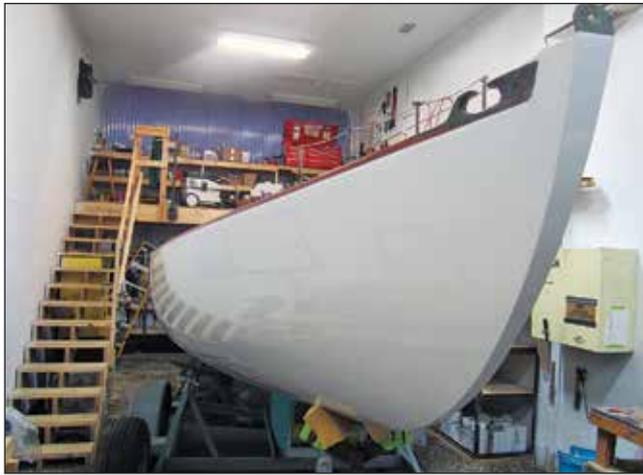
WHISPER, a Buzzards Bay 15 built by Artisan in 2010, just after receiving her annual topside paint last winter. Her hull looks flawless.
